SINGLE SURVEY

Survey report on:

Selling address	11 Crown Drive Inverness IV2 3NN
------------------------	--

Prepared by	Keith Campbell, Assoc.RICS Inverness - Allied Surveyors Scotland Plc
--------------------	---

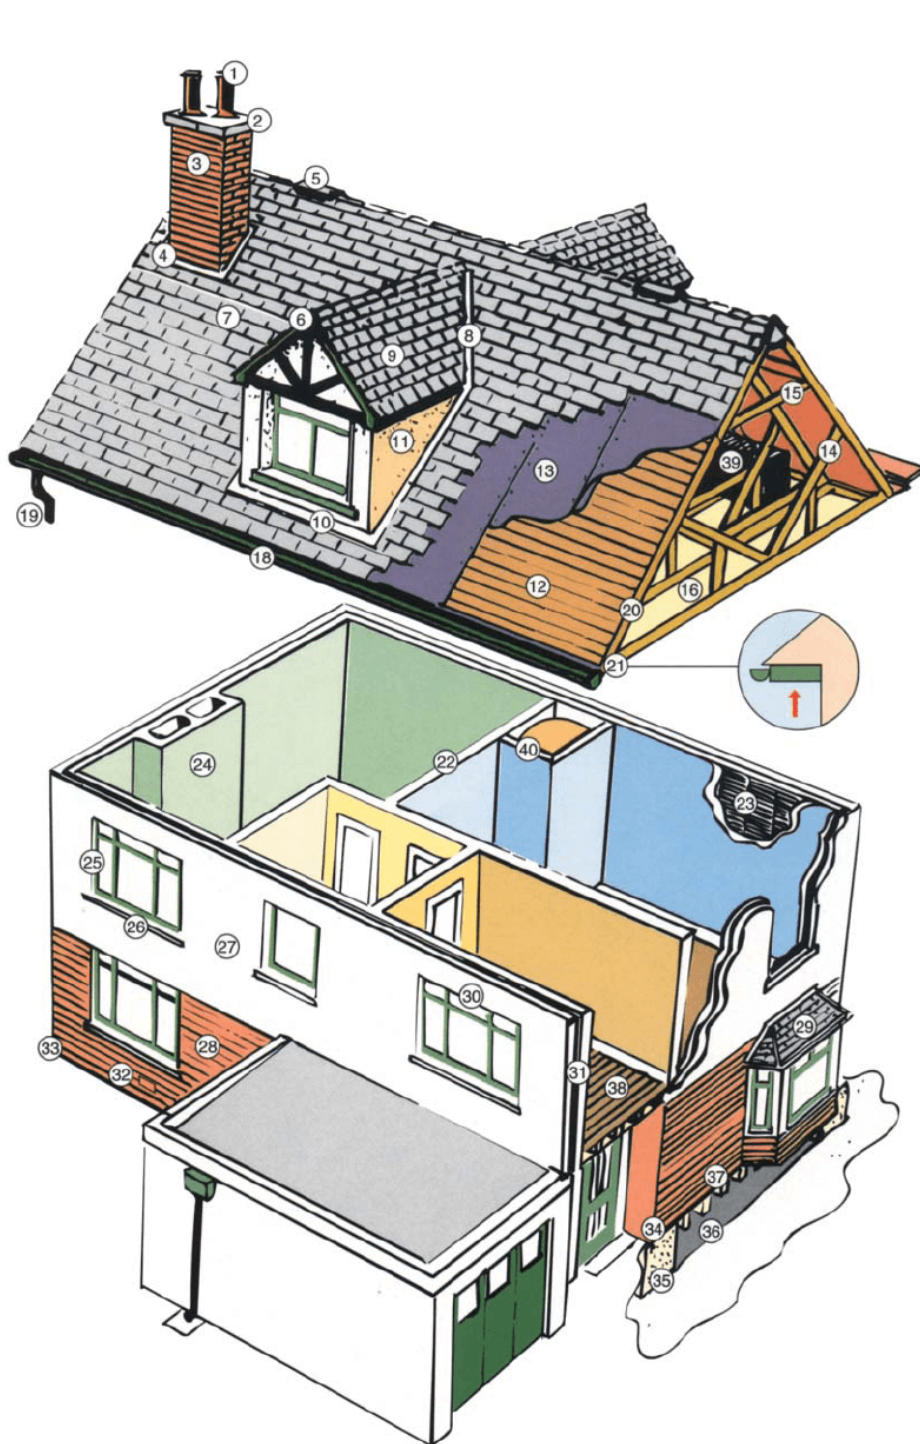
Sectional Diagram showing elements of a typical house

- ① Chimney pots
- ② Coping stone
- ③ Chimney head
- ④ Flashing
- ⑤ Ridge ventilation
- ⑥ Ridge board
- ⑦ Slates / tiles
- ⑧ Valley guttering
- ⑨ Dormer projection
- ⑩ Dormer flashing
- ⑪ Dormer cheeks
- ⑫ Sarking
- ⑬ Roof felt
- ⑭ Trusses
- ⑮ Collar
- ⑯ Insulation
- ⑰ Parapet gutter
- ⑱ Eaves guttering
- ⑲ Rainwater downpipe
- ⑳ Verge boards /skews
- ㉑ Soffit boards
- ㉒ Partiton wall
- ㉓ Lath / plaster
- ㉔ Chimney breast
- ㉕ Window pointing
- ㉖ Window sills
- ㉗ Rendering
- ㉘ Brickwork / pointing
- ㉙ Bay window projection
- ㉚ Lintels
- ㉛ Cavity walls / wall ties
- ㉜ Subfloor ventilator
- ㉝ Damp proof course
- ㉞ Base course
- ㉟ Foundations
- ㊱ Solum
- ㊲ Floor joists
- ㊳ Floorboards
- ㊴ Water tank
- ㊵ Hot water tank

Reference may be made in this report to some or all of the above component parts of the property. This diagram may assist you in locating and understanding these items.
